**IEPA - DIVISION OF WATER POLLUTION CONTROL  
DIGITAL PHOTO REPORT**

<b>Date:</b> 4-24-13	<b>Site Name:</b> Meier Land & Cattle, LLC
<b>Photo By:</b> Lee Heeren	 
<b>County:</b> Stephenson	
<b>Comments:</b> This beef feedlot utilizes a liquid protein and energy product in the beef rations. The product is called delactosed permeate. It is essentially the protein removed from whey and condensed to 35% solids. The product arrives in a 6,000 gal. tanker from Juda, Wisconsin.	
<b>Photo #:</b> 1	
<b>Photo Title:</b> 042413_MeierLand&Cattle_LH(1)

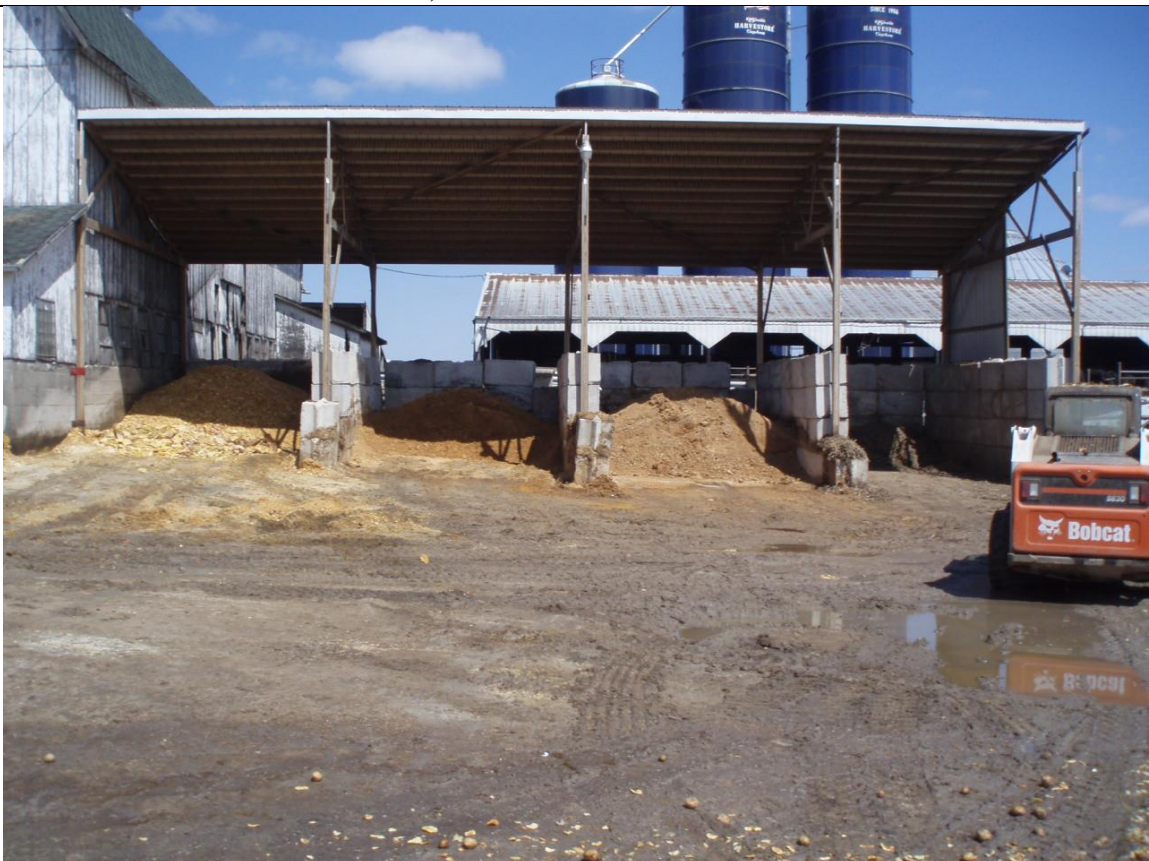
<b>County:</b> Stephenson	
<b>Comments:</b> A view of the commodity storage shed constructed in 2010. Notice the spillage of feed outside the storage shed. View is north.	
<b>Photo #:</b> 3	
<b>Photo Title:</b> 042413_MeierLand&Cattle_LH(4)

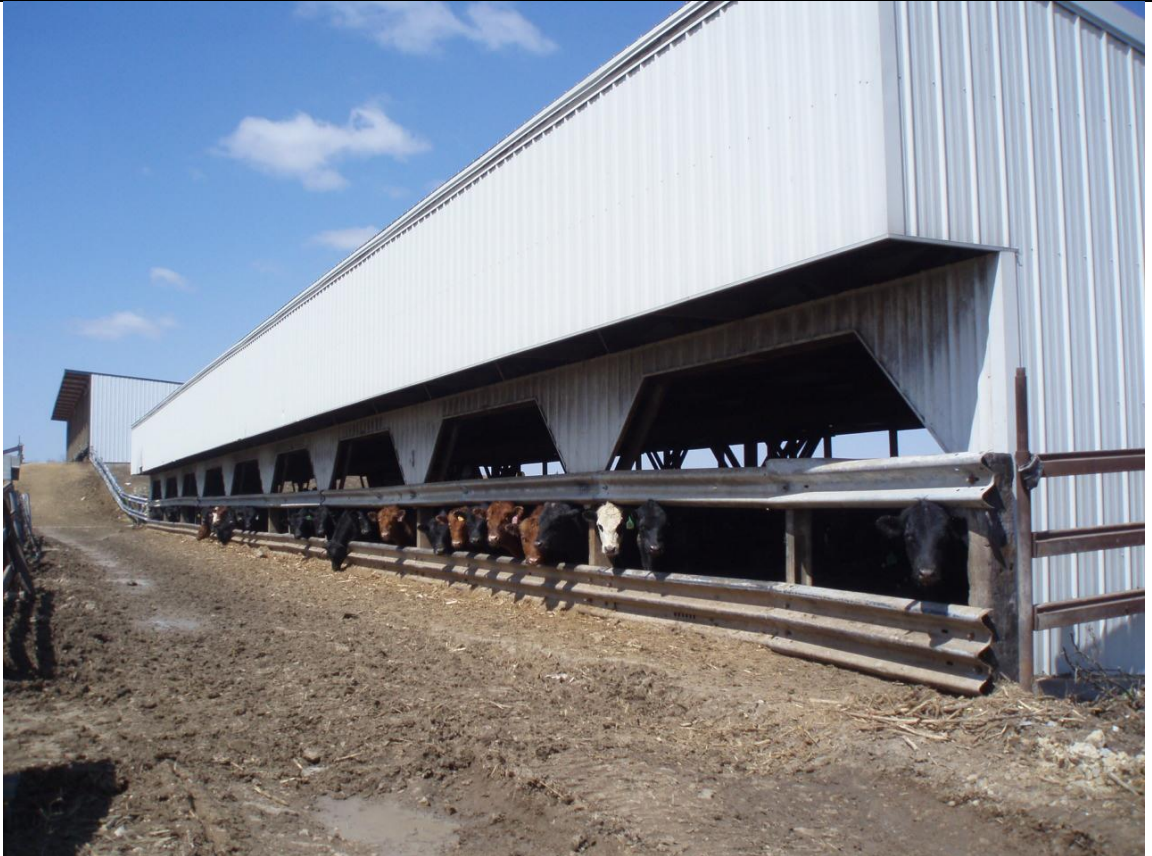
<b>County:</b> Stephenson	
<b>Comments:</b> A view of Barn #3 that measures 50' x 164'. It also has a partial manure pit 12'W x 6'D. The capacity of this building is 200 cattle. View is northwest.	
<b>Photo #:</b> 7	
<b>Photo Title:</b> 042413_MeierLand&Cattle_LH(8)

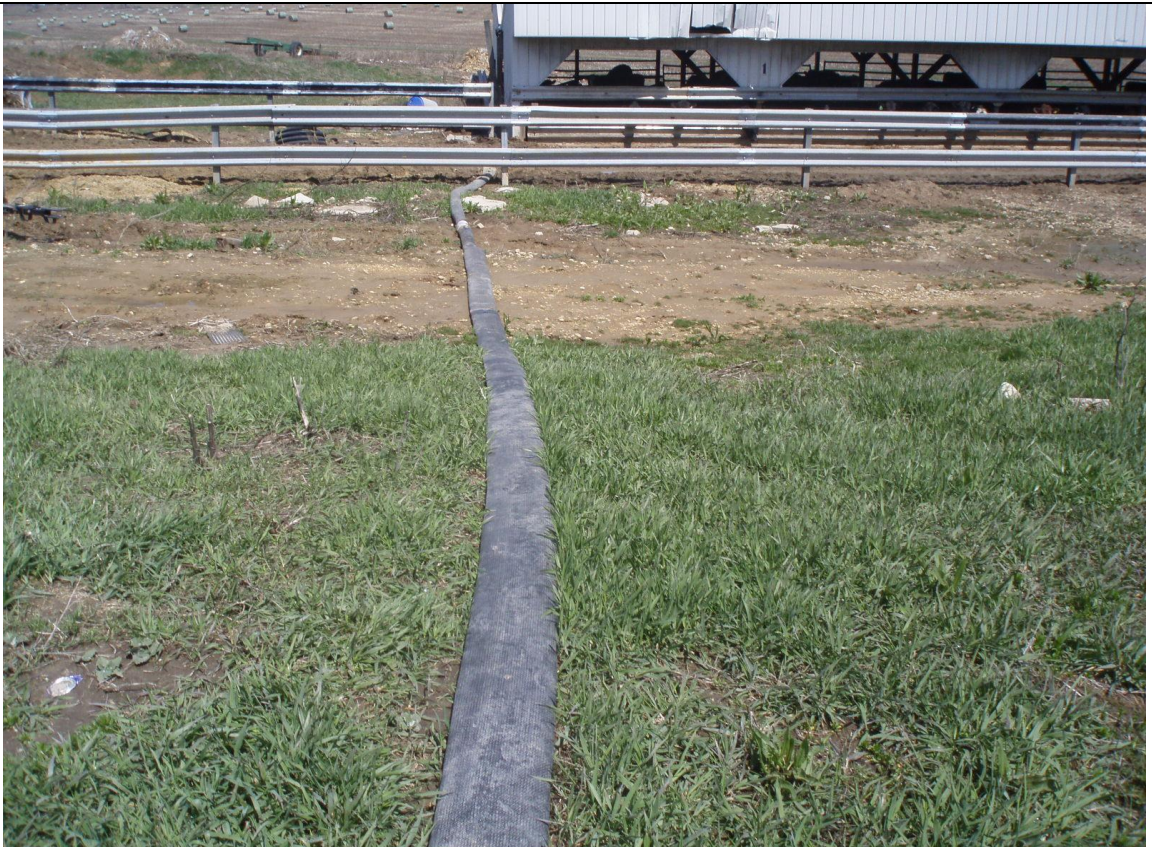
<b>County:</b> Stephenson	
<b>Comments:</b> Barns #2 and #3 containing the partial manure pits have limited storage capacity and requires the manure to be transferred to the earthen storage basin. The hose pictured is used to make this transfer. View is north toward Barn #3.	
<b>Photo#:</b> 10	
<b>Photo Title:</b> 042413_MeierLand&Cattle_LH(2)
